ONN Monitoring Report:

ACTIVITIES CONTINUE AT THE ABANDONED 50 MWE REACTOR AT YONGBYON

Veronika Bedenko

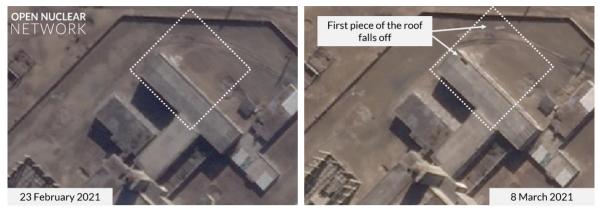
The first changes to the roof of the building in question can be traced back to some time between 23 February and 8 March 2021, when the first piece of roofing was removed or had fallen from the building (see Figure 1). An object of a size and color matching the now absent part of the roof appeared to be placed in close proximity to the building. As no other signs of construction were spotted on the site of the facility at that time, and given that the site had been abandoned for decades and underwent the only visible maintenance 10 years ago, ³it is reasonable to conclude that the change in the roof was likely to have been the result of damage by strong wind or some other natural cause rather than purposeful dismantlement,

Figure 1. Imagery shows that the first change to the roof happened between 23 February and 8 March 2021.

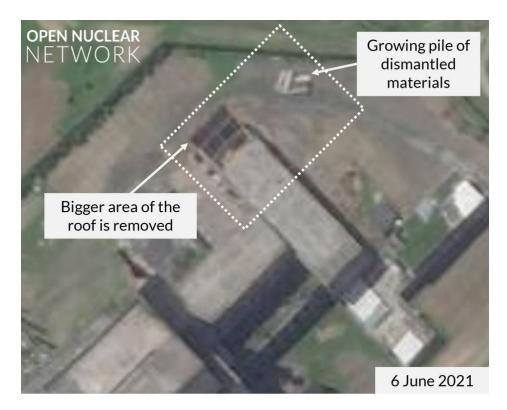
Since the March 2021 change to the roof, the building remained intact, with no significant changes detected until mid-May 2021. Analysis of available high resolution imagery from Planet for the period 13 May to 6 June 2021 indicated that the roof had undergone further modification (see Figure 2). Most likely, the change occurred between 22 and 26 May, as indicated by the 3-meter resolution imagery from Planet. Satellite imagery from 6 June revealed that material removed from the roof had been collected and piled next to the previously removed part, which points to the ongoing dismantlement activity.

Figure 2. Further dismantlement of the roof detected in satellite imagery from 6 June 2021. Image © 2021 Planet Labs Inc. All Rights Reserved. Reprinted by permission.

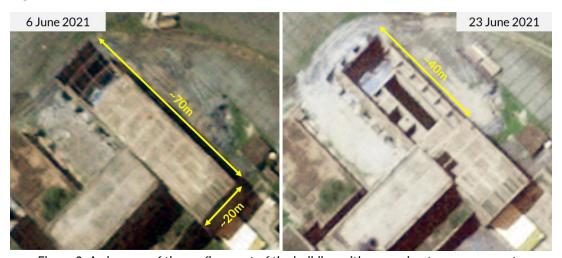
The next significant modification of the roof was seen in Planet imagery from 23 June, as reported in ONN's previous monitoring report. The size of the uncovered part of the building was approximately 40×20 meters, revealing a little over half of the inside layout of the building (see Figure 3).

Figure 3. A close-up of the roofless part of the building with approximate measurements. Image © 2021 Planet Labs Inc. All Rights Reserved. Reprinted by permission.

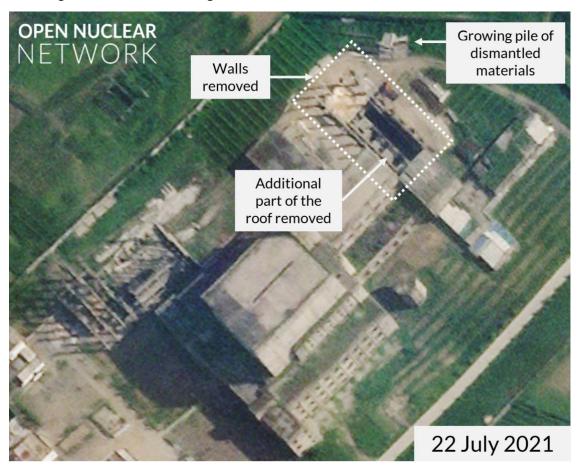
The latest satellite imagery, from 22 July, shows that activity at the site has continued and progressed considerably. Within one month, the roof was dismantled further and the walls of the building were removed (see Figure 4).

Figure 4. Continued dismantlement activities are observed on the satellite imagery from 22 July. Image © 2021 Planet Labs Inc. All Rights Reserved. Reprinted by permission.

The recent changes to the building show clearly that demolition activities have been in progress. The ultimate purpose of these activities still remains unclear.

If the 50 MWe reactor project was truly abandoned, the building would have decayed naturally, which could have triggered the current dismantlement activities. Frank Pabian,⁷ an expert in satellite imagery analysis, added that the dismantlement could have started due to safety considerations:

Since this site has been decommissioned for almost 30 years, I would believe that age and weather has taken its toll, causing the roof to be unstable and, hence, its removal for safety reasons.⁸
