# **ASSESSMENT OF THE IMPACT OF AUGUST 2021 RAINFALL AND FLOODING IN THE DPRK**

Katsuhisa FURUKAWA, Veronika BEDENKO, Jaewoo SHIN,  
XU Tianran

September 2021

In August 2021, the Democratic People's Republic of Korea (DPRK) experienced heavy rainfall and severe flooding. ONN has analysed available open-source information and identified locations of possible damage and assessed the scope of such damage. This paper provides a summary of ONN's findings.

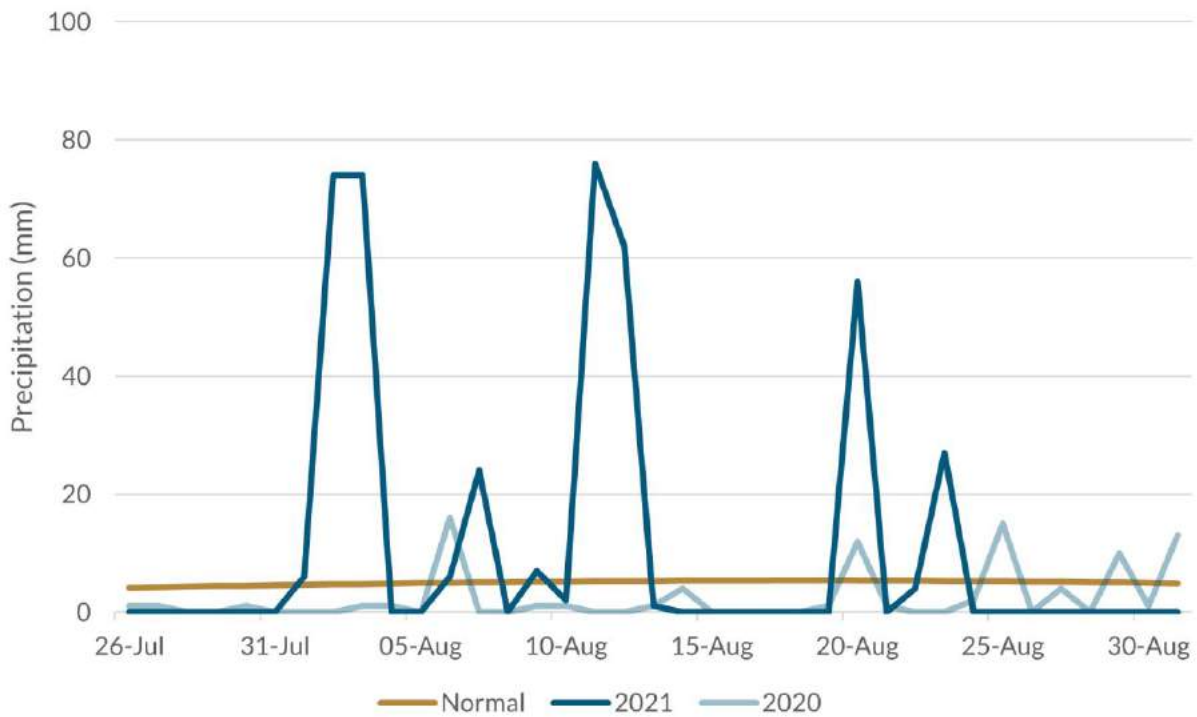
Figure 2.a. Precipitation at Chongjin, North Hamgyong Province  
Source: World Meteorological Organization

higher than historical averages,<sup>4</sup> in particular on or around three specific periods (1-3 August, 10-13 August and 21 August), as can be seen in Figures 2.a through 2.d below. Most of these spikes also exceeded those recorded during the same time period in 2020.

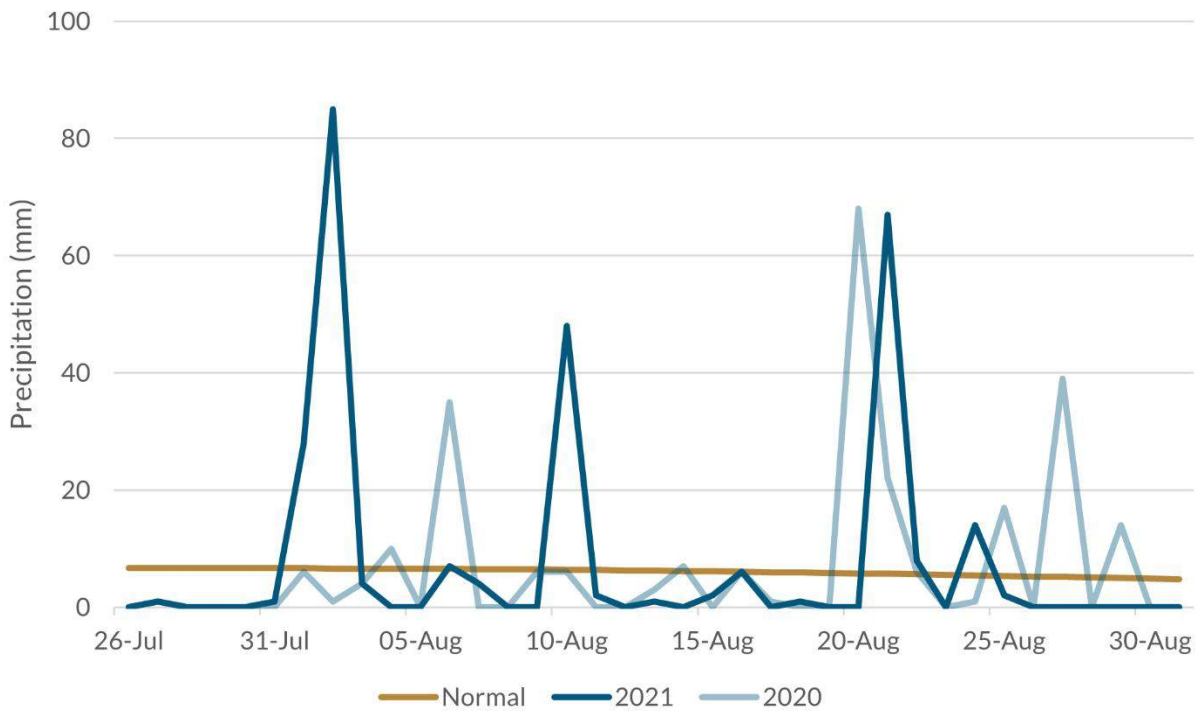
Figure 2.b. Precipitation at Pungsan, Ryanggang Province  
Source: World Meteorological Organization

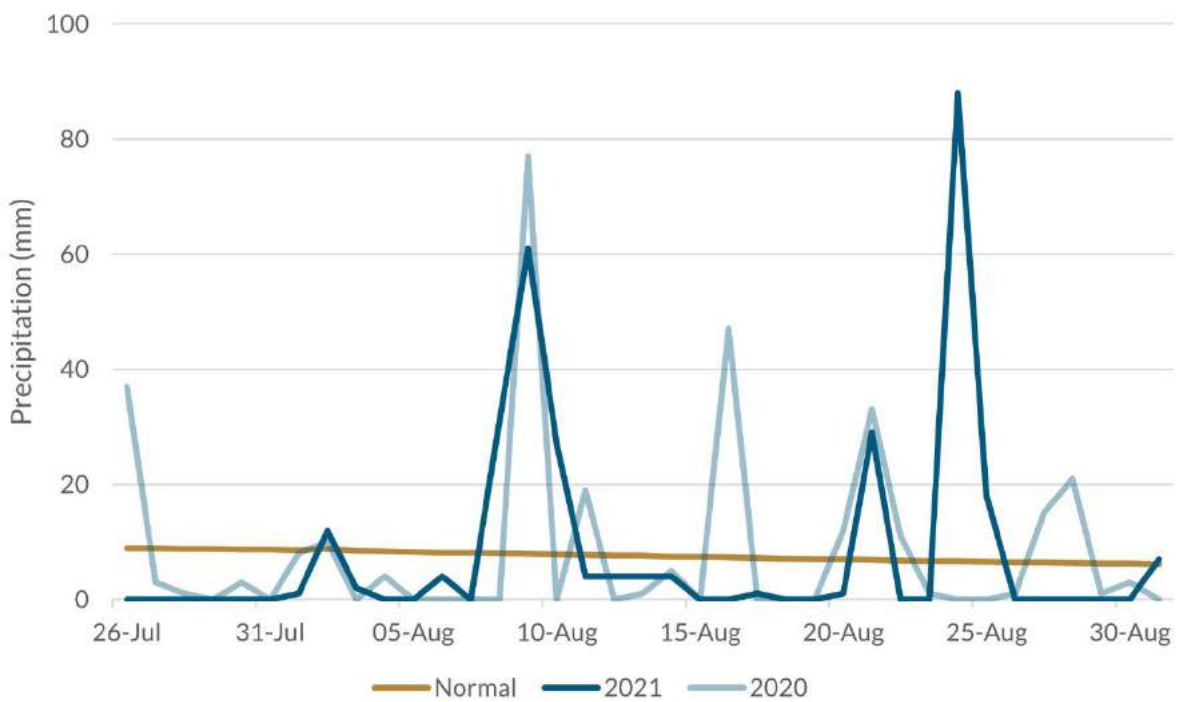
Figure 2.c. Precipitation at Wonsan, Kangwon Province  
Source: World Meteorological Organization

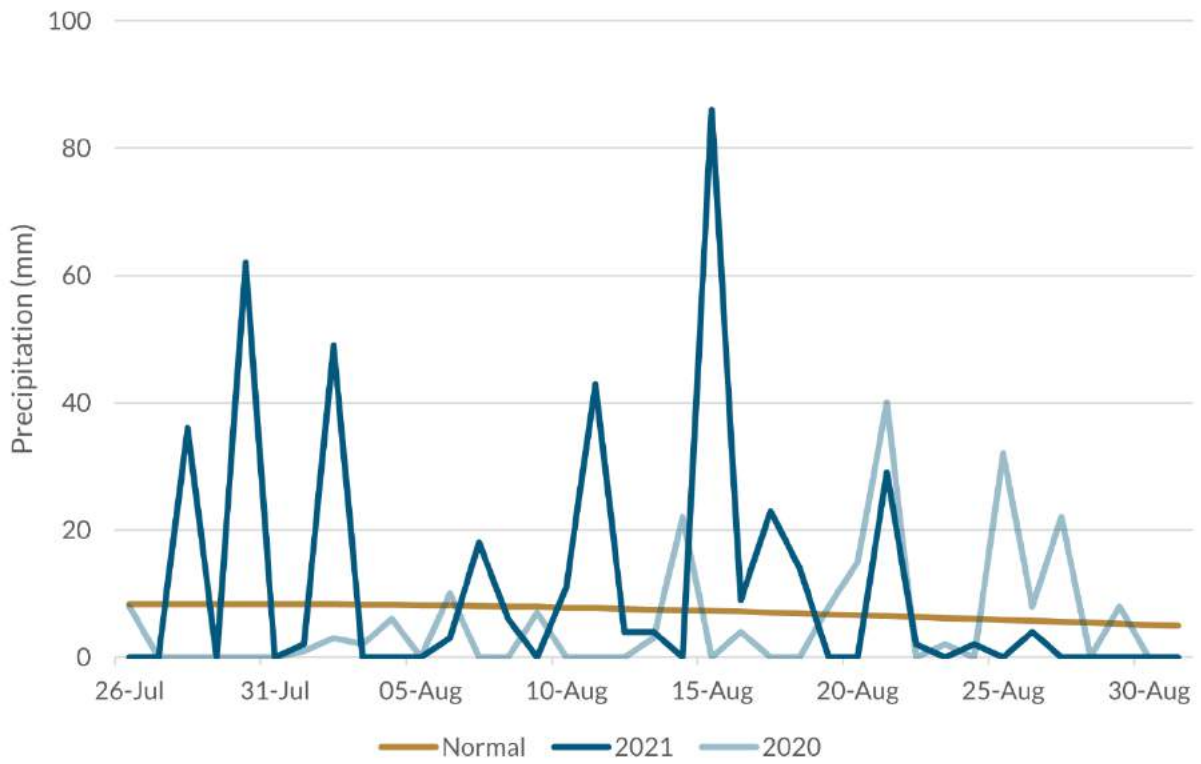
Figure 2.d. Precipitation at Kanggye, Chagang Province  
Source: World Meteorological Organization

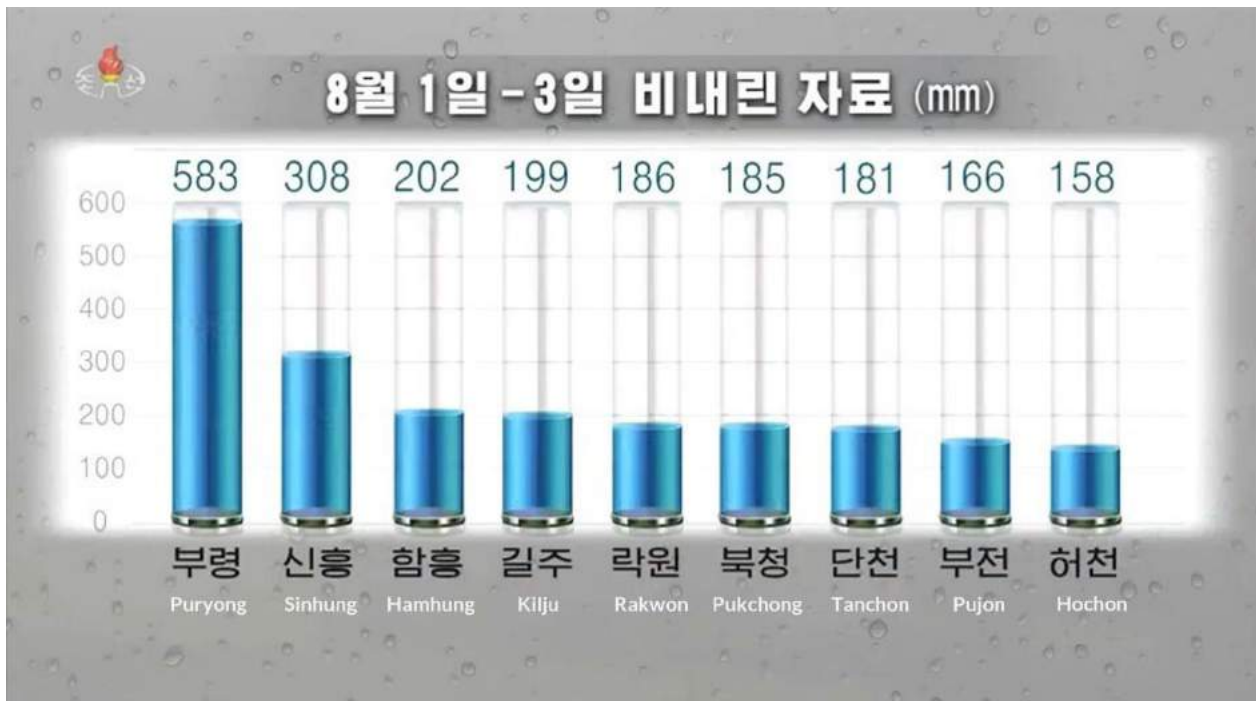
According to KCTV, Puryong County in North Hamgyong Province experienced the greatest volume of rainfall in the DPRK and recorded the highest precipitation level of 583 mm between 1 and 3 August 2021. Sinhung County in South Hamgyong Province recorded the second highest precipitation level of 308 mm for the same period (Figure 3).<sup>5</sup>

Province, and Kilju County in North Hamgyong Province, which recorded precipitation levels between 158 and 202 mm for the same period (Figure 3).

Figure 3. Highest precipitation levels in cities and counties in South and North Hamgyong Province, 1-3 August 2021

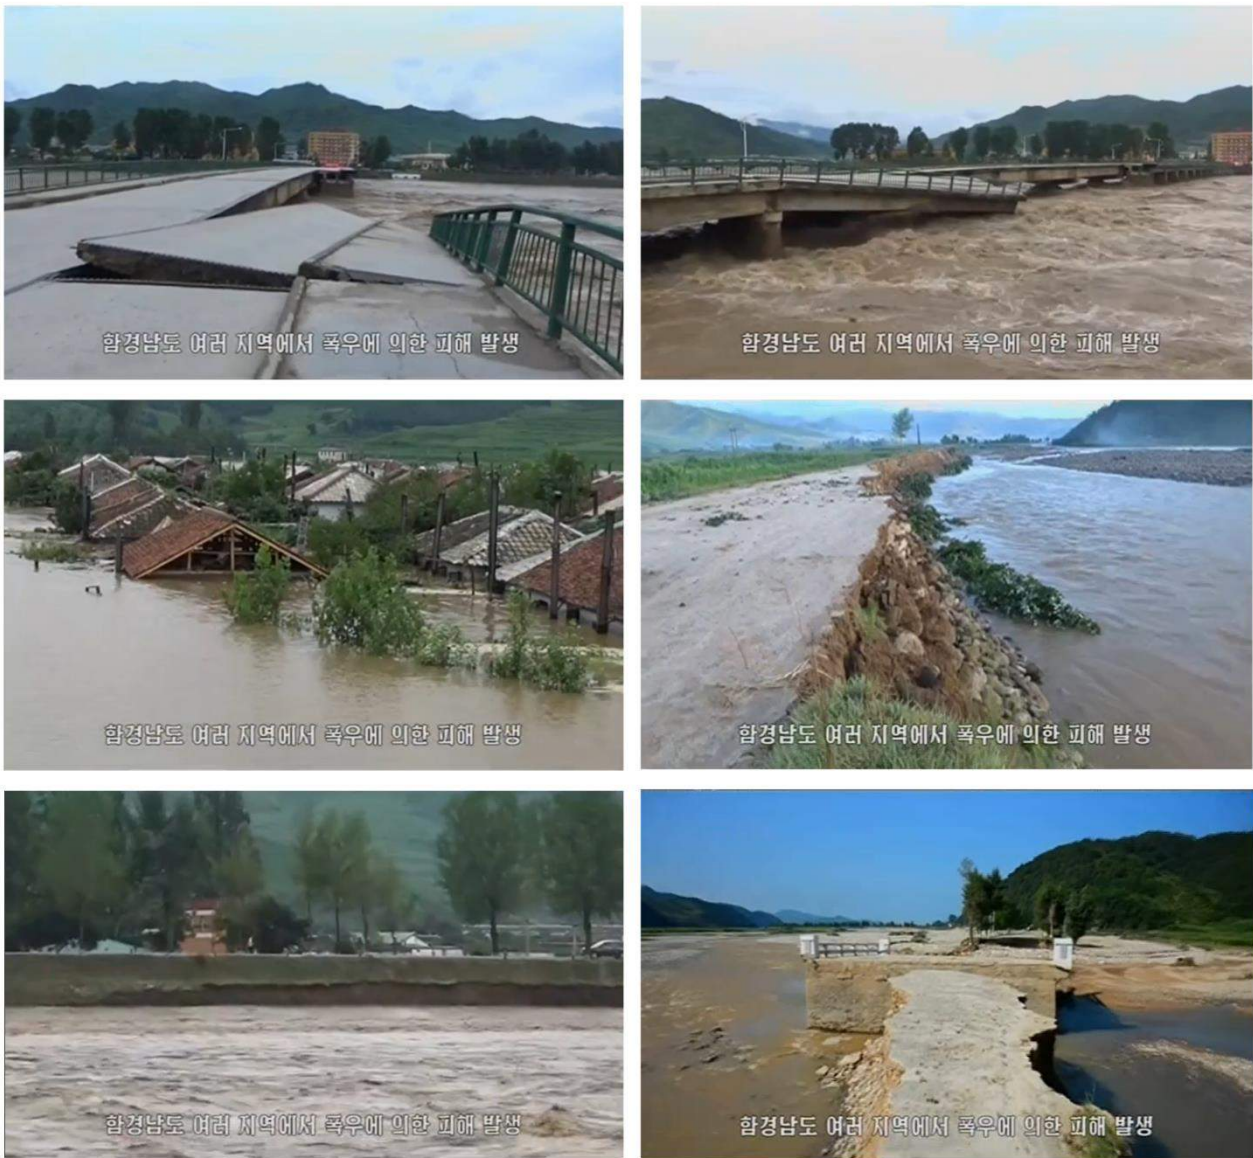
KCTV aired video footage showing extensive damage to South Hamgyong Province caused by heavy rainfall and severe flooding, in particular, to houses, roads, bridges and agricultural fields (Figure 4). Subsequent reporting by Rodong Sinmun and Korea Central News Agency (KCNA) identified damage to other areas in the South and North Hamgyong Provinces, including Hongwon County and Yonggwang County in South Hamgyong Province and Puryong County in North Hamgyong Province.<sup>6</sup>

Figure 4. Damage due to heavy rainfall and flooding between 1 and 3 August 2021 in South Hamgyong Province. The caption in the Korean script states, "Numerous areas in South Hamgyong Province were damaged by the rainstorms."

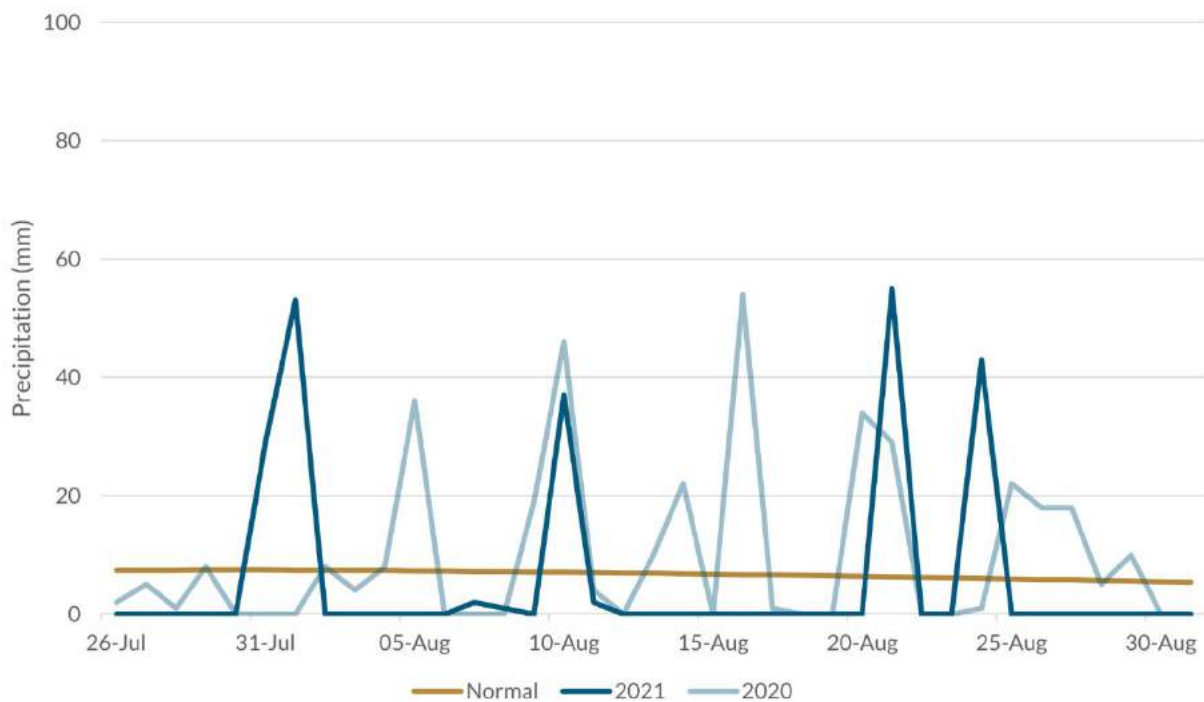
DPRK media frequently referred to Hamhung as one of the areas that was significantly affected by heavy rainfall and flooding and where reconstruction activities were being undertaken. High precipitation levels in Hamhung were recorded on 1, 10 and 21 August (Figure 6).

Figure 6. Precipitation at Hamhung, South Hamgyong Province  
Source: World Meteorological Organization

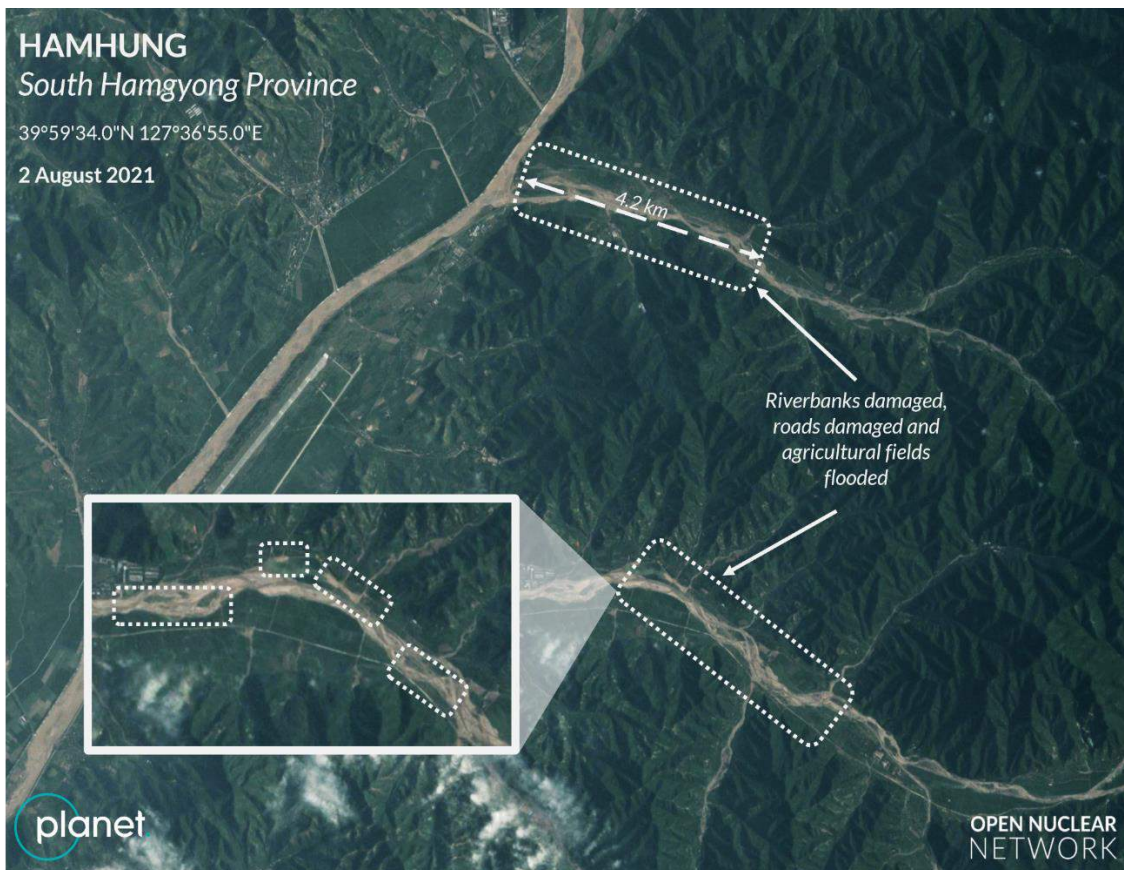
In addition, flooding caused by heavy rainfall in several mountain ridges damaged residential areas and roads along the rivers in the valleys (Figures 7 to 9).

Figure 8. Along one of the other rivers, riverbanks and roads were damaged and agricultural fields were flooded (about 4.2 km) on 2 August 2021.

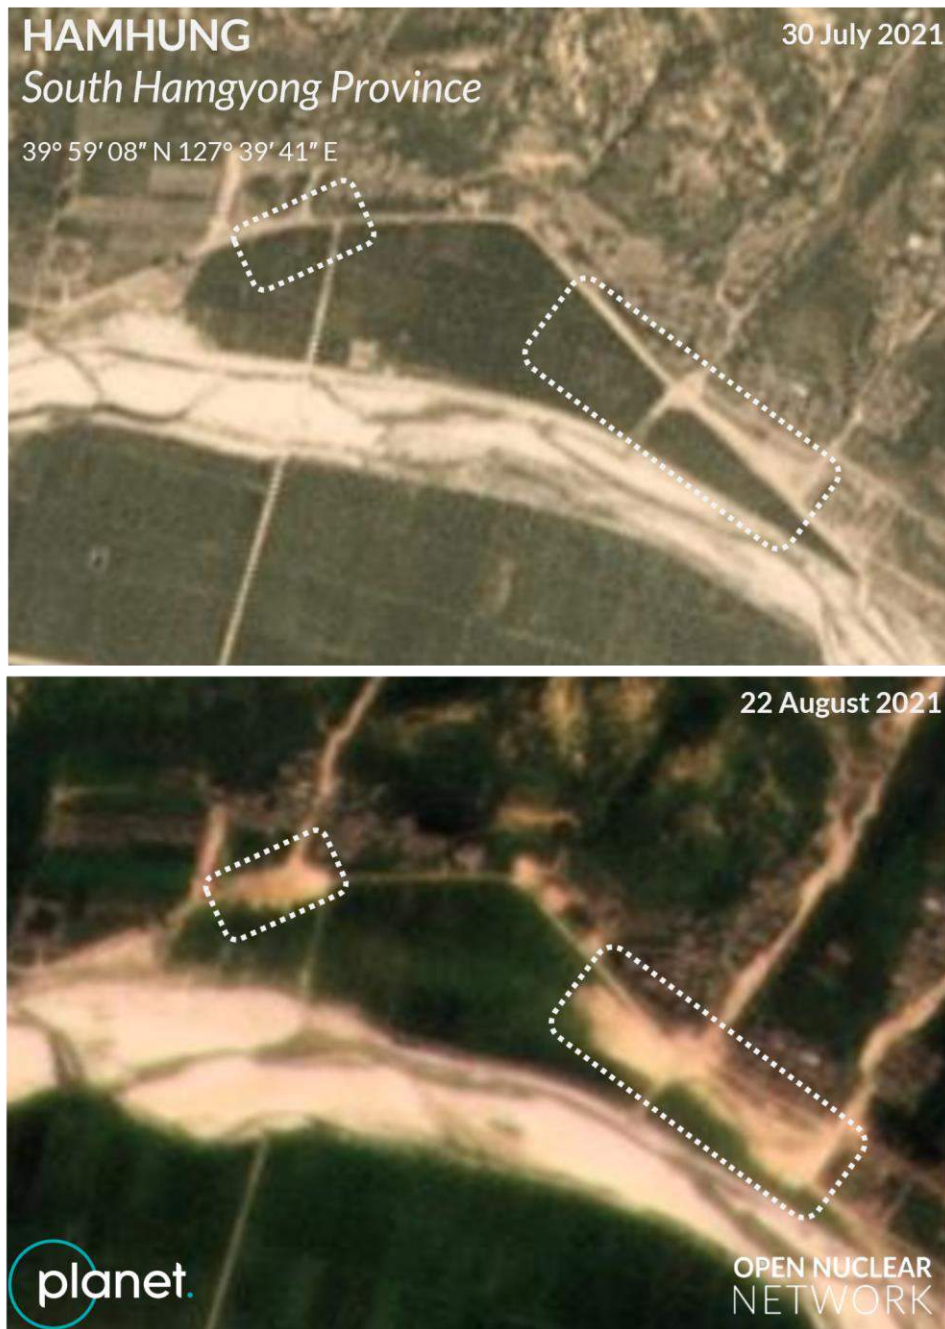
Figure 9. Agricultural fields were washed away during the flooding on 2 August 2021. Image © 2021 Planet Labs Inc. All Rights Reserved. Reprinted by permission.

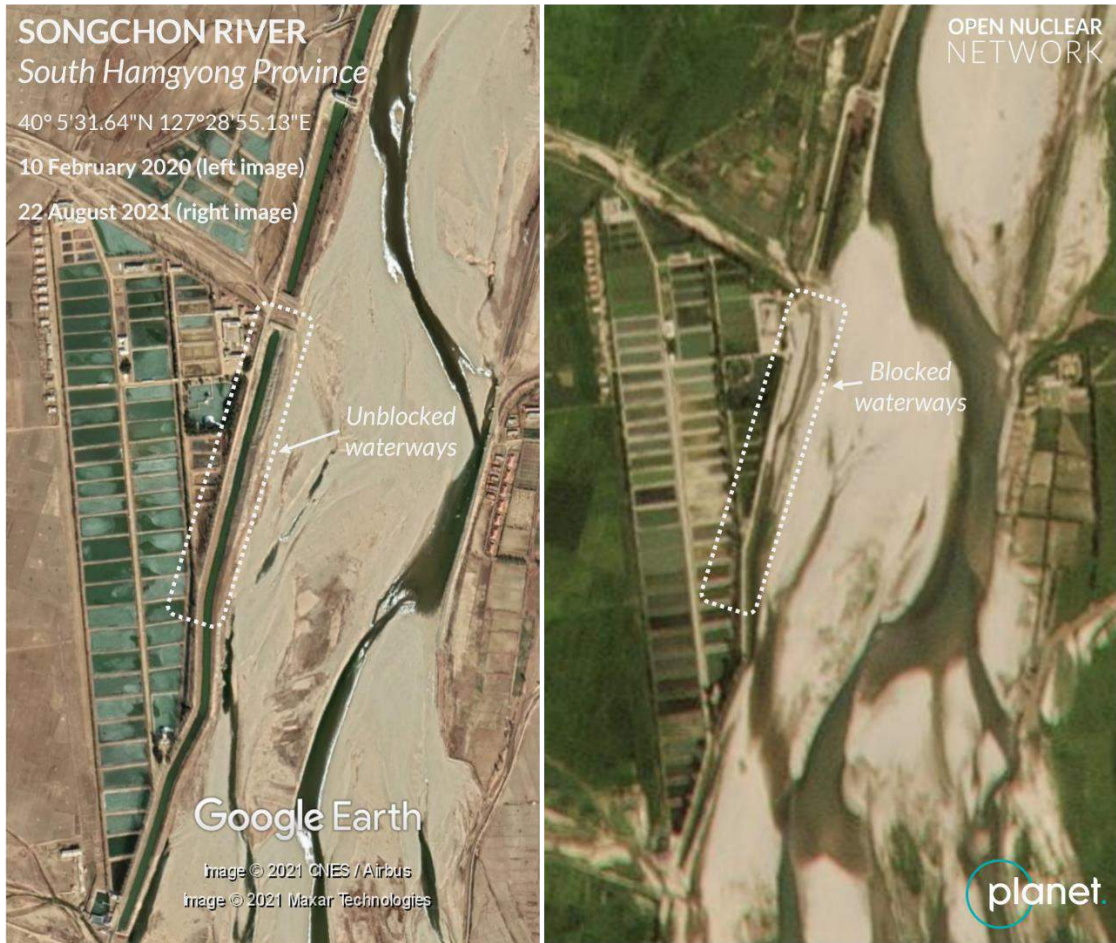
In addition, several waterways along the Songchon River were filled with sediment or destroyed during the flooding (Figure 12). These waterways may have been used as irrigation canals or for the purpose of supplying water to fisheries or agricultural areas. The damage to these waterways could negatively impact agricultural and fishery operations in the surrounding area.

Figure 12. Example of damage to waterways along the Songchon River.  
Images: Google Earth and Planet Labs  
Image © 2021 Planet Labs Inc. All Rights Reserved. Reprinted by permission

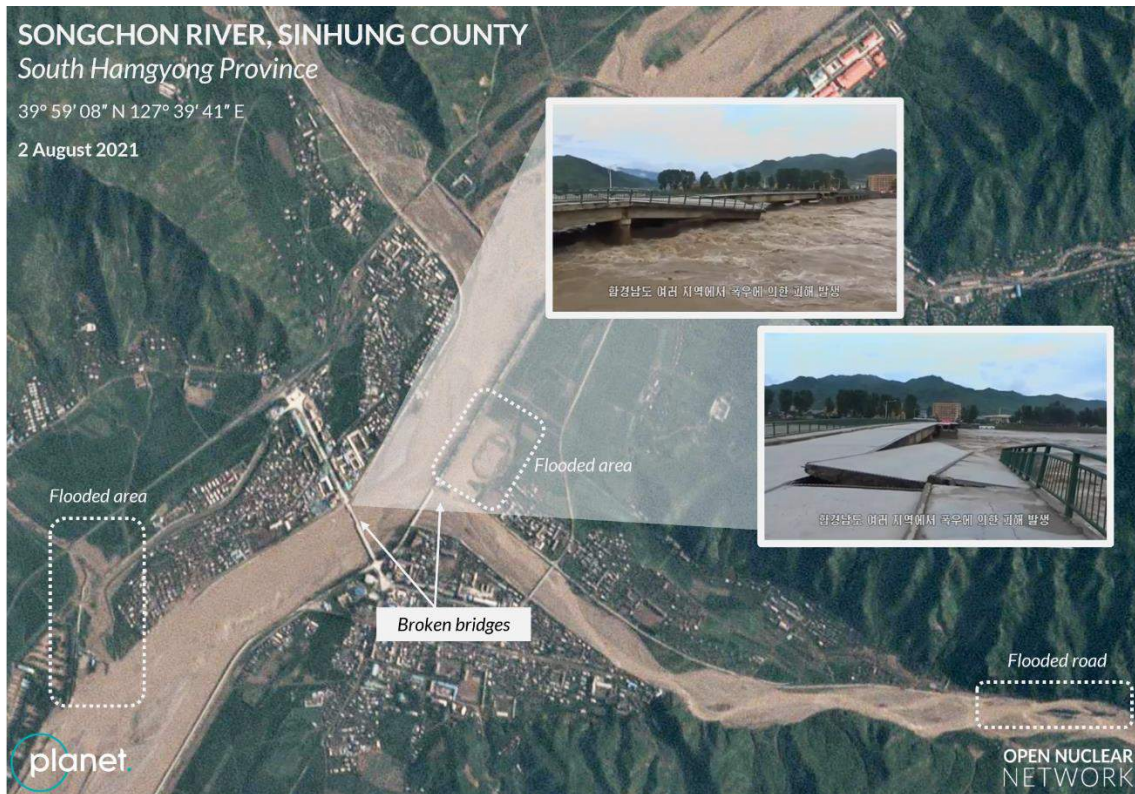
extensive flooding in the centre of the county and two damaged bridges (Figure 13).<sup>13</sup>

Figure 13. Examples of damage to waterways along the Songchon River and damaged bridges in Sinhung County.

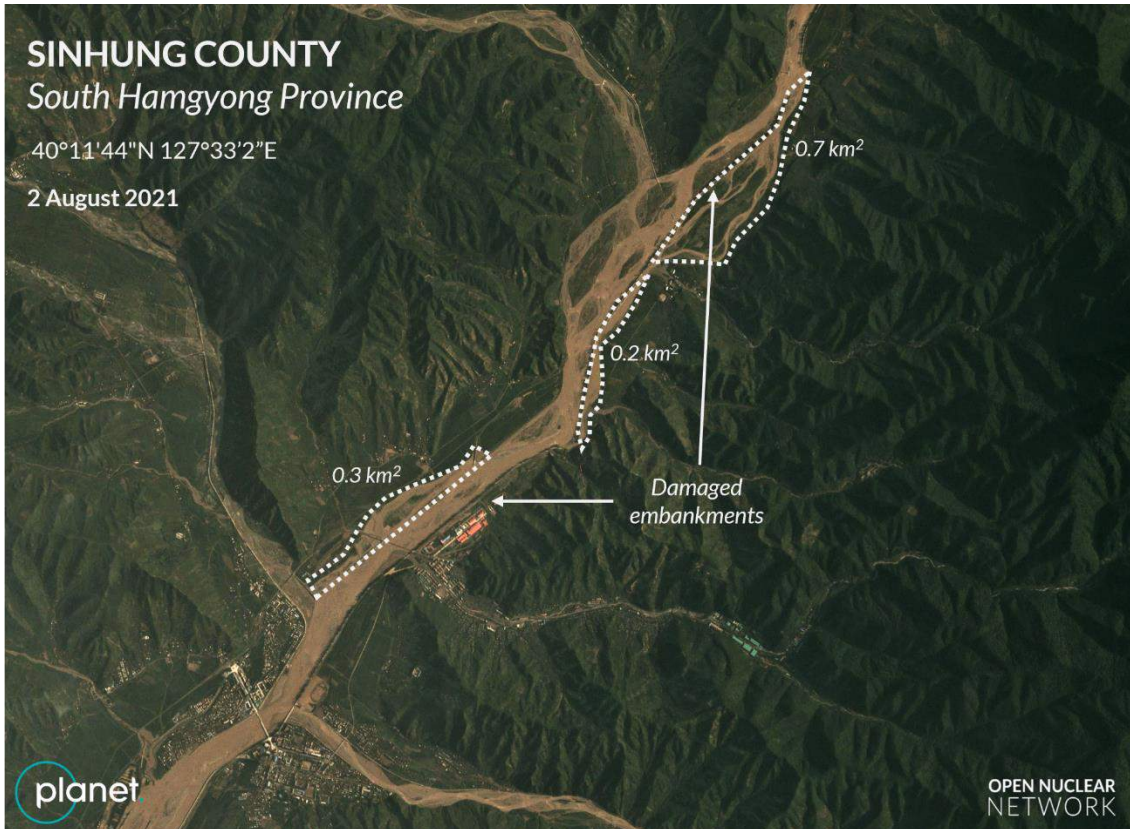
To the north of the county's centre, an approximately 1.3 km of the river embankment were damaged, and approximately 1.2 km<sup>2</sup> of agricultural fields were flooded (Figure 14).

Figure 14. Flooding and damaged embankments north of the centre of Sinhung County. Image © 2021 Planet Labs Inc. All Rights Reserved. Reprinted by permission

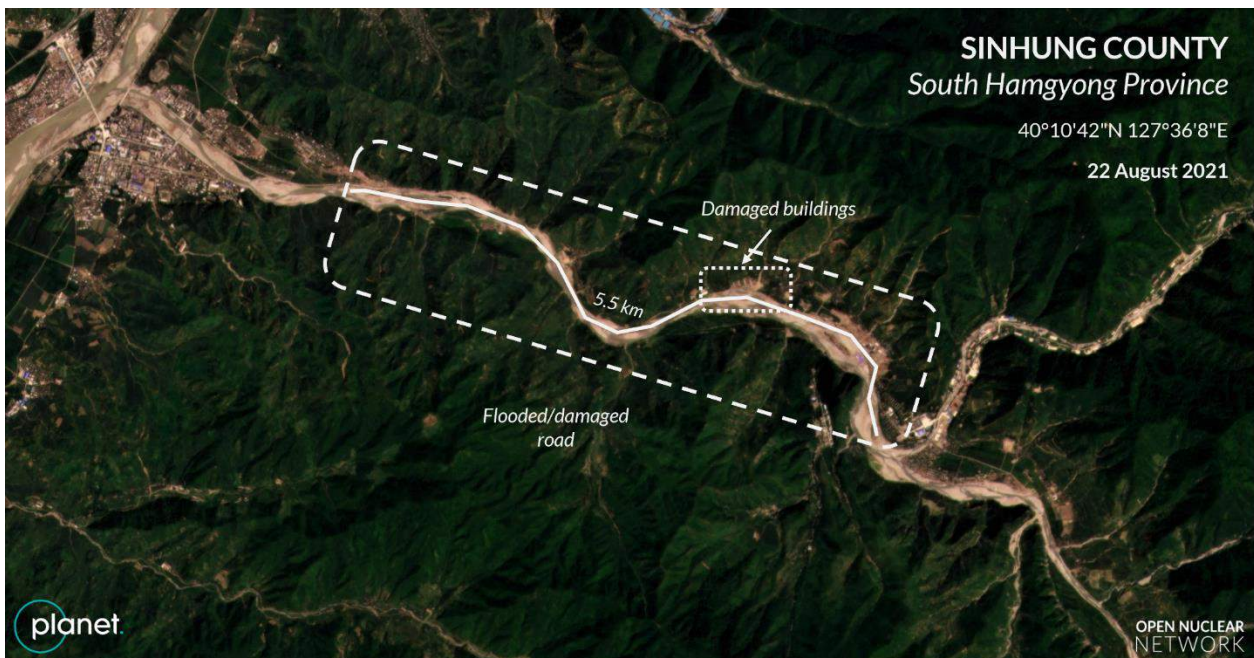
To the east of the county's centre, an approximately 5.5 km length of a road was flooded and/or damaged, which resulted in the isolation of a town (Figure 15).

Figure 15. Flooding east of the centre of Sinhung County. Image © 2021 Planet Labs Inc. All Rights Reserved. Reprinted by permission.

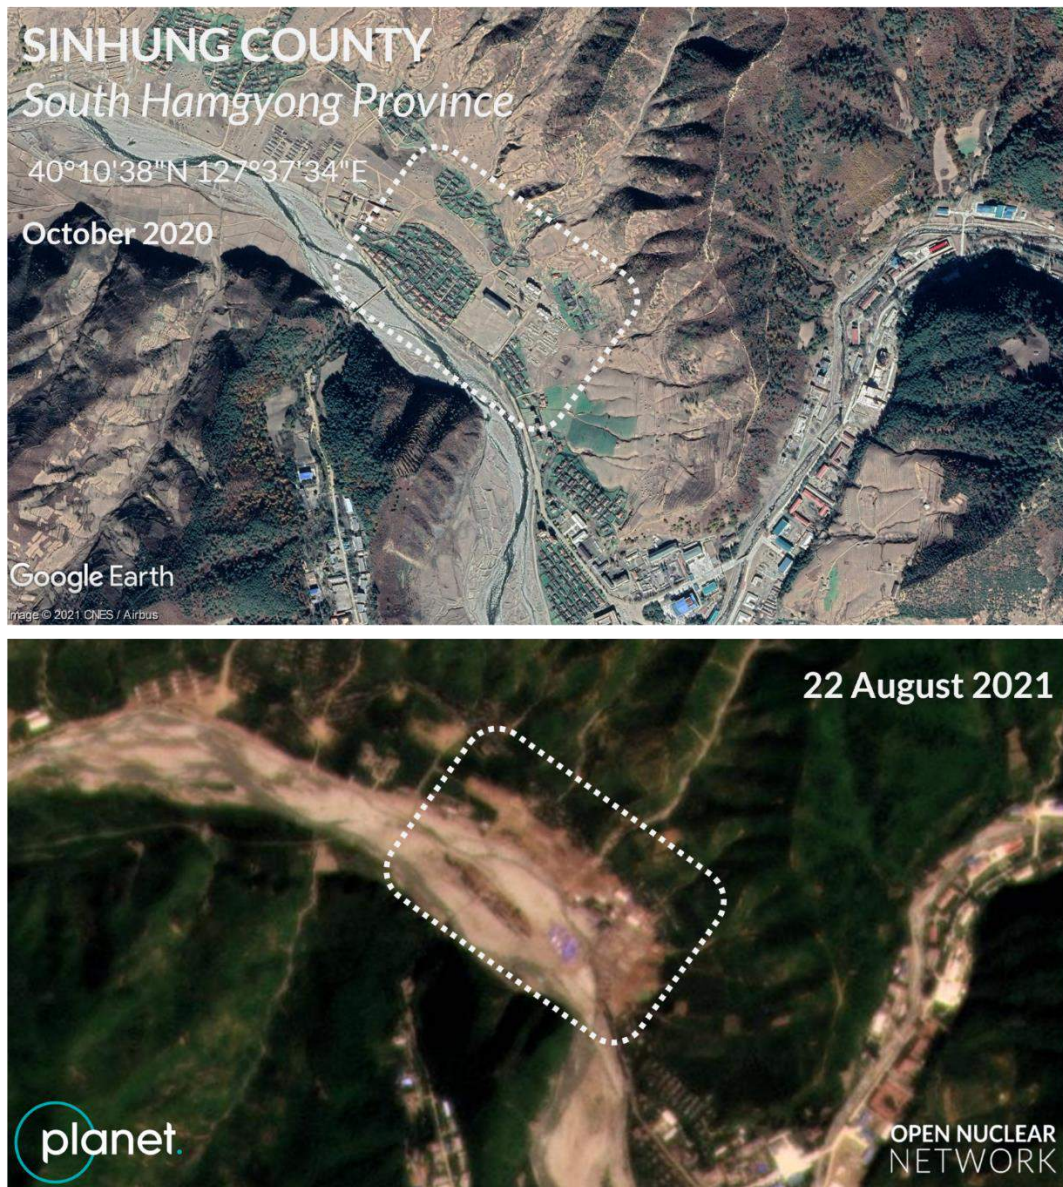
Along the damaged road, a residential district was almost completely washed away (Figure 16) and a number of houses or buildings also disappeared (Figures 16 and 17).<sup>14</sup>

Figure 16. Residential district washed away east of Sinhung County's centre in early August.

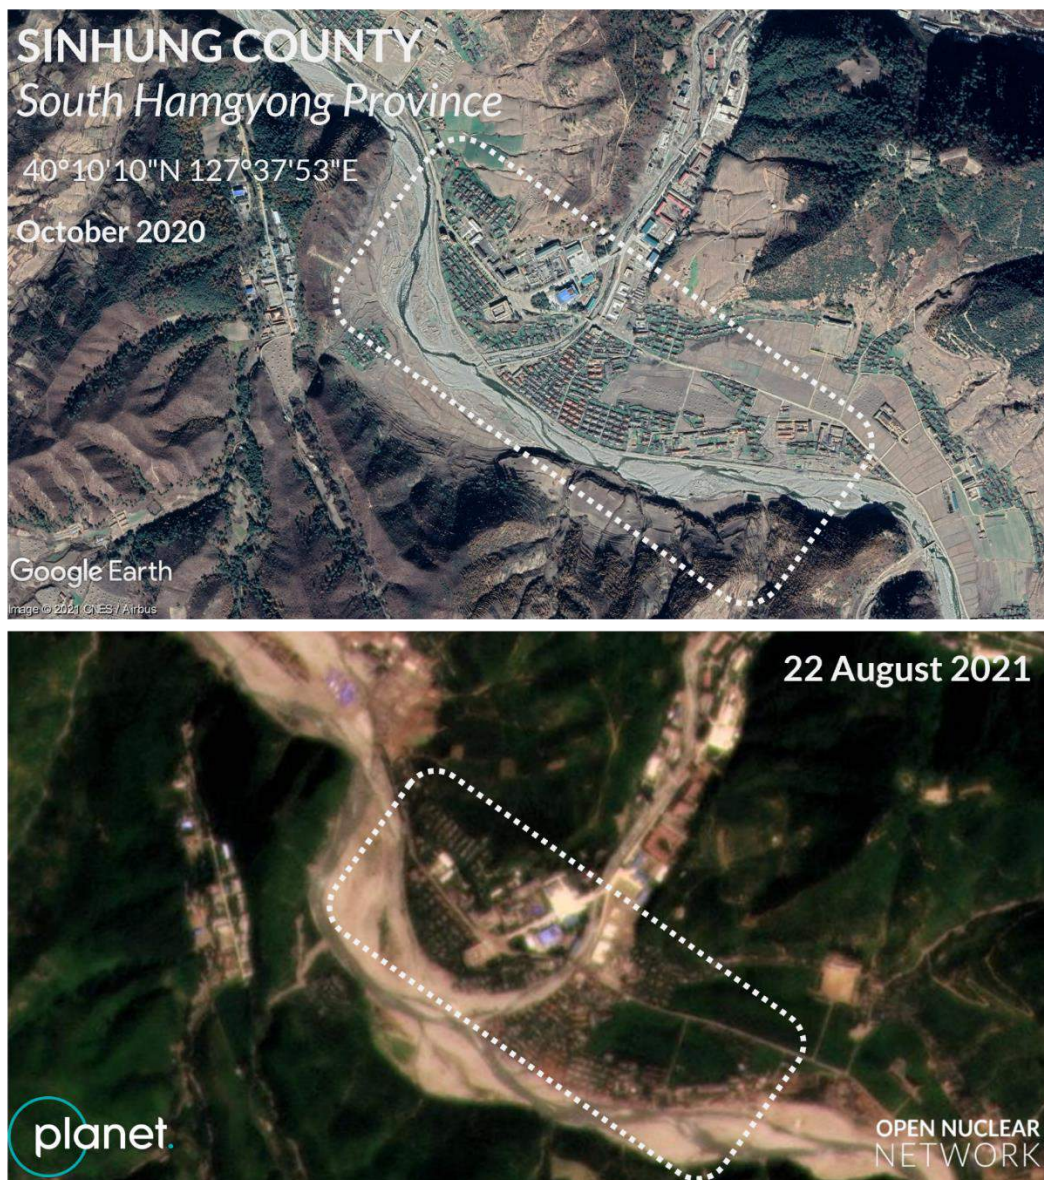
Figure 17. Houses and other buildings washed away further east of Sinhung County's centre in early August.

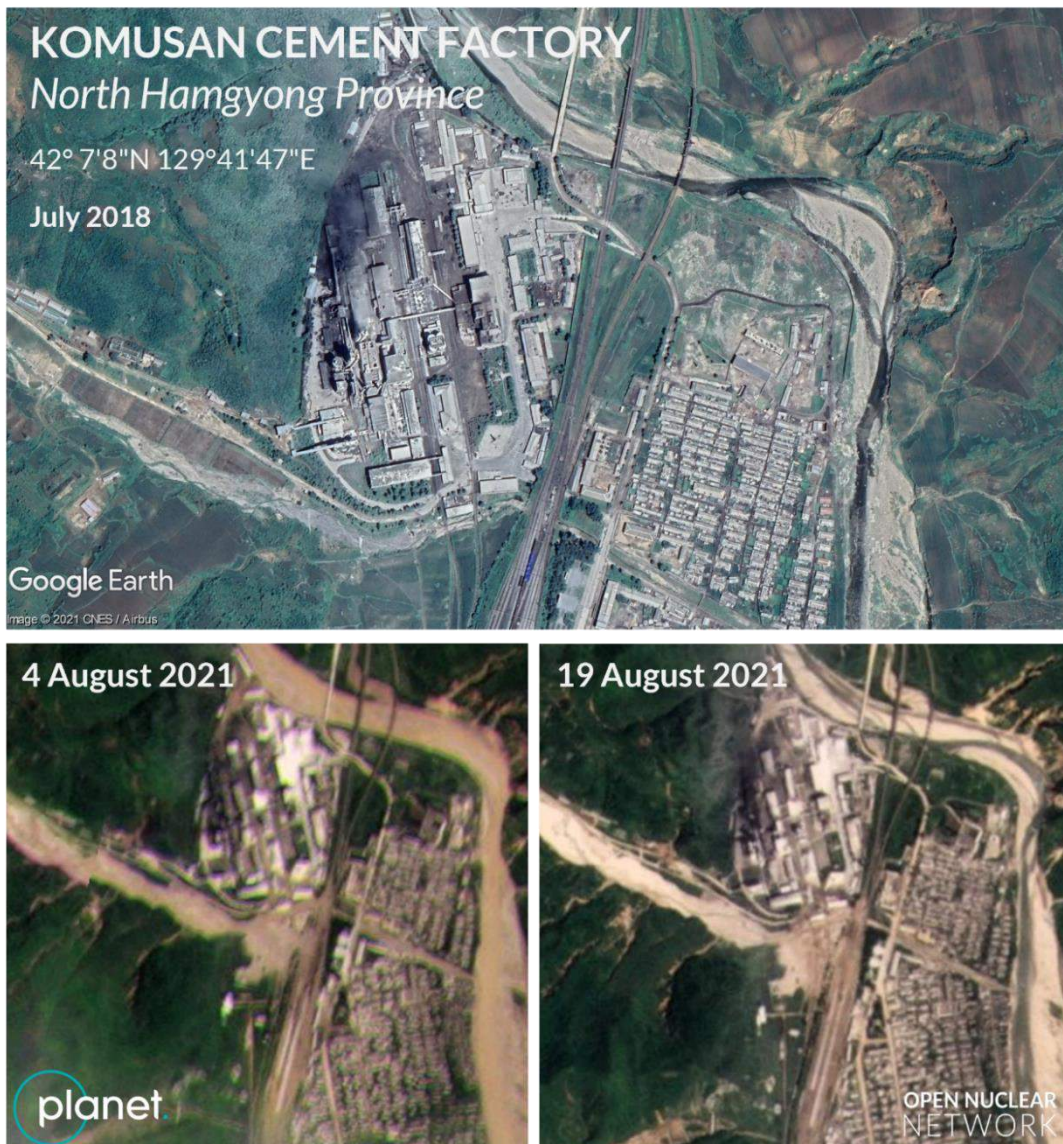
Komusan in North Hamgyong Province was also affected by the heavy rainfall and flooding (Figure 18). Noteworthy, in

particular, is the damage to the Komusan Cement Factory. According to a report in DPRK media, the factory is equipped with “a high-quality refractory workshop” and has served as one of the key producers of cement products in North Hamgyong Province (Figure 18).<sup>15</sup> Satellite imagery from 3-4 August shows that the railways used by this factory and the Komusan train station close to the factory were flooded. Satellite imagery from 19 August shows that the railways appeared to have been still covered by sediment, indicating that the damage had not yet been repaired. Prolonged damage to these railways could constrain local capacity to produce and supply cement products to reconstruction sites in the affected areas.

Figure 18. Satellite imagery showing flooded railways near the Komusan Cement Factory (bottom left). Traces of the damage to railways can be observed in satellite imagery from 19 August (bottom right). Images: Google Earth and Planet Labs  
Image © 2021 Planet Labs Inc. All Rights Reserved. Reprinted by permission

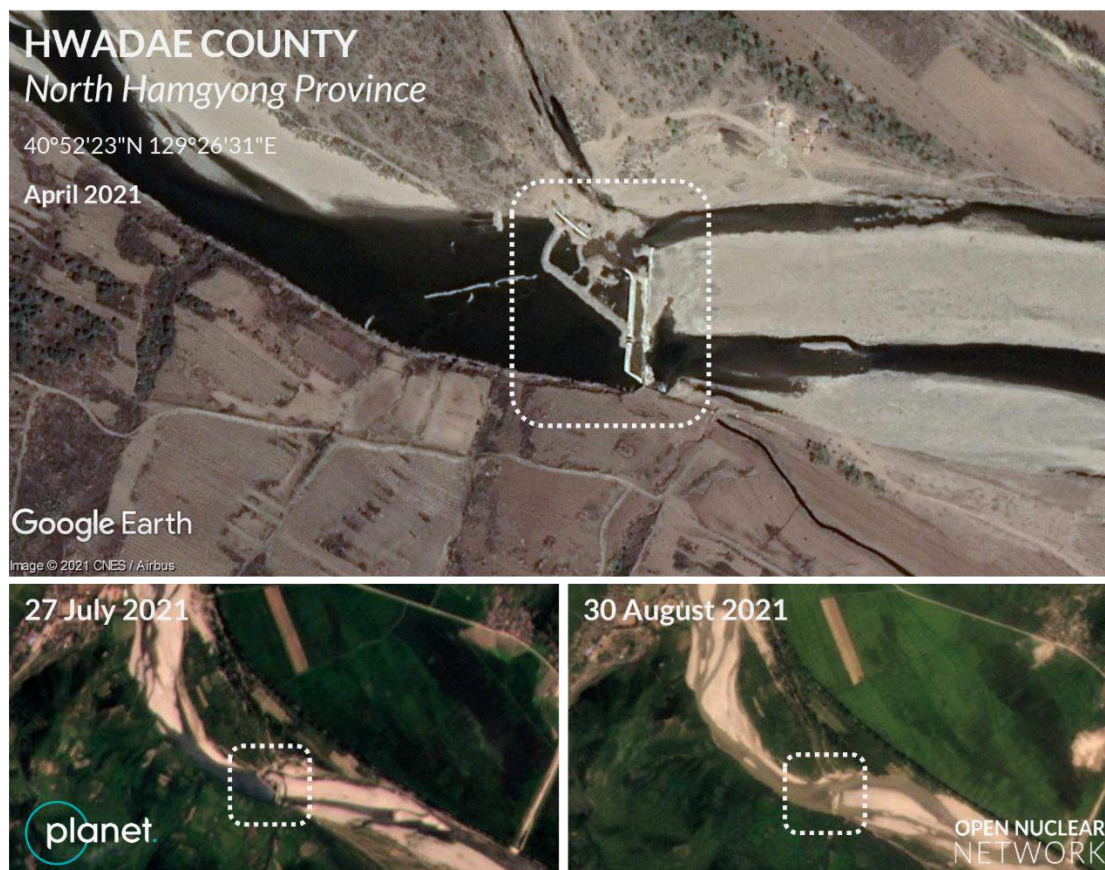
In addition, there is a river weir approximately 8 km upstream from the flooded bridge which was almost completely flooded and possibly destroyed.

Figure 20. River weir near Hwadae County completely flooded in August.  
Images: Google Earth and Planet Labs  
Image © 2021 Planet Labs Inc. All Rights Reserved. Reprinted by permission

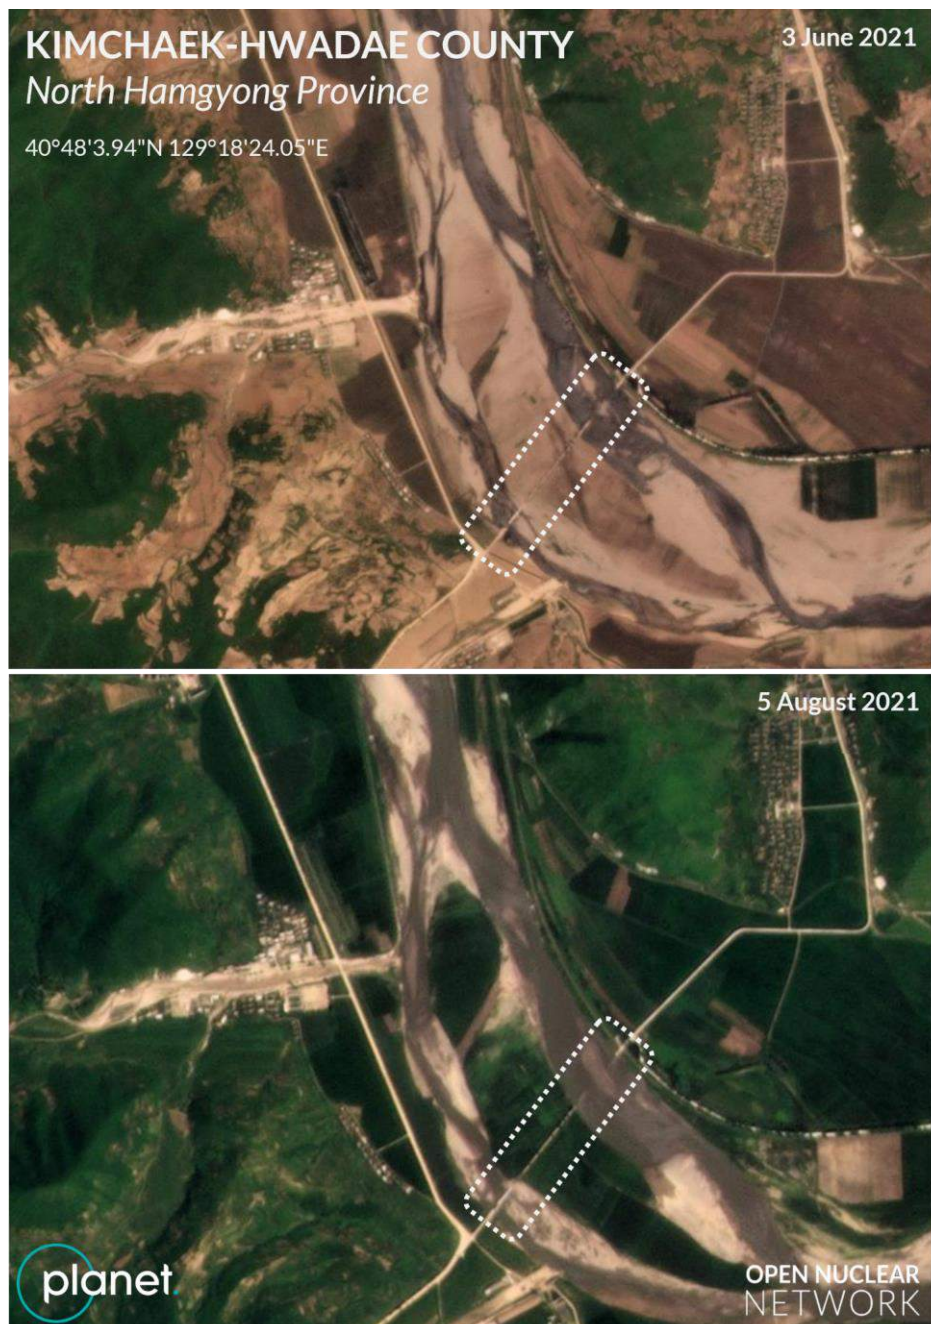
A key bridge over the Namdaechon River at the administrative border between Hwadae County and Kimchaek has also been adversely impacted by the heavy rain and flooding. The bridge was already damaged sometime before 3 June 2021 and was further damaged by flooding in August. As of 30 August, the bridge had still not been repaired (Figure 21).

Figure 21. A damaged bridge near Chagundojang-dong. Image © 2021 Planet Labs Inc. All Rights Reserved. Reprinted by permission.

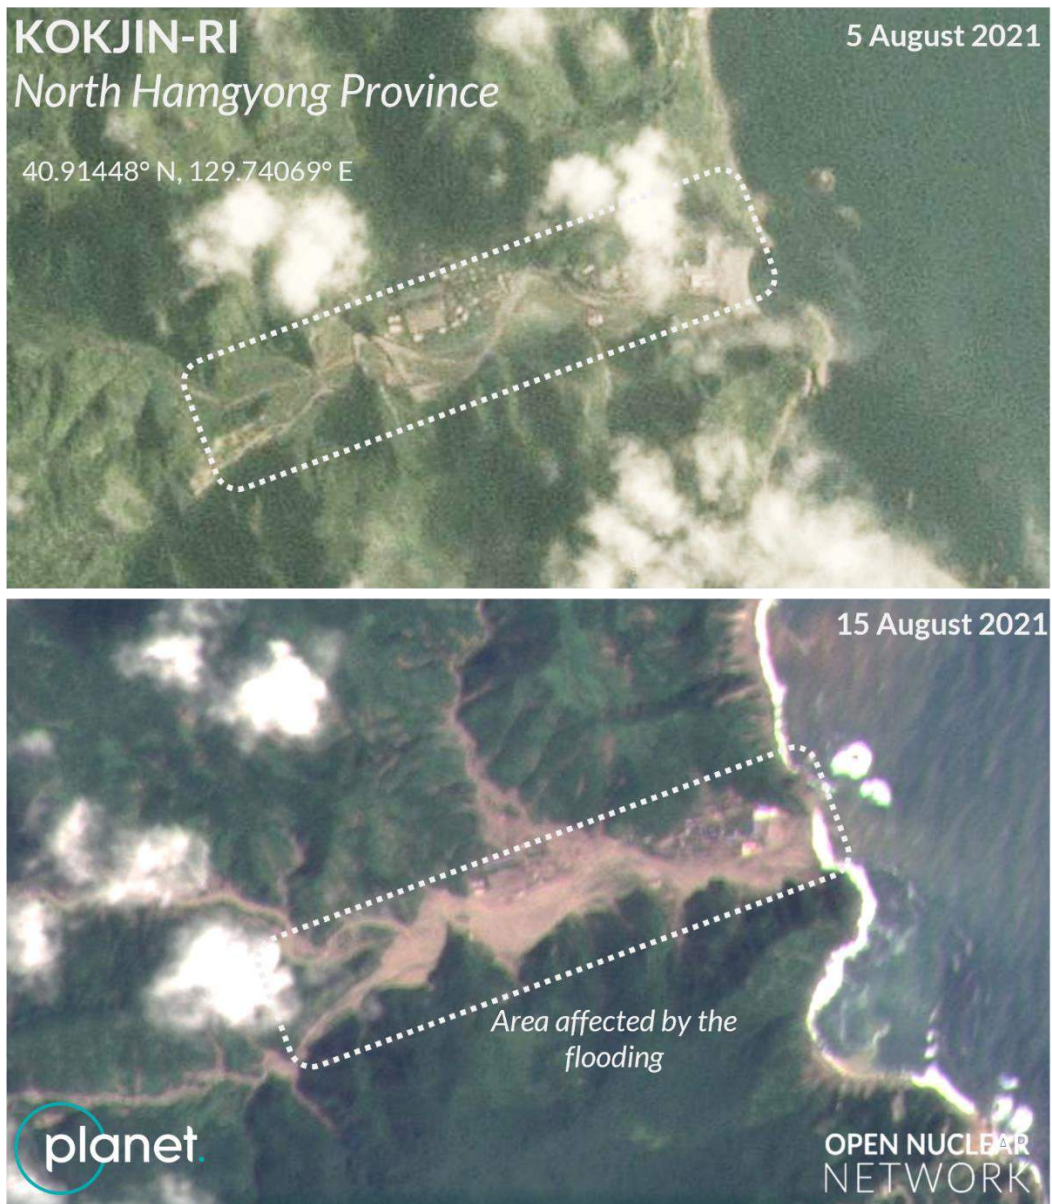
The village of Kokjin-ri on the east coast of Hwadae County was also flooded in early August (Figure 22).<sup>16</sup> The water had not yet receded as of 3 September.

Figure 22. Satellite images from 5 August and 15 August showing flooding of Kokjin-ri on the east coast of Hwadae County.

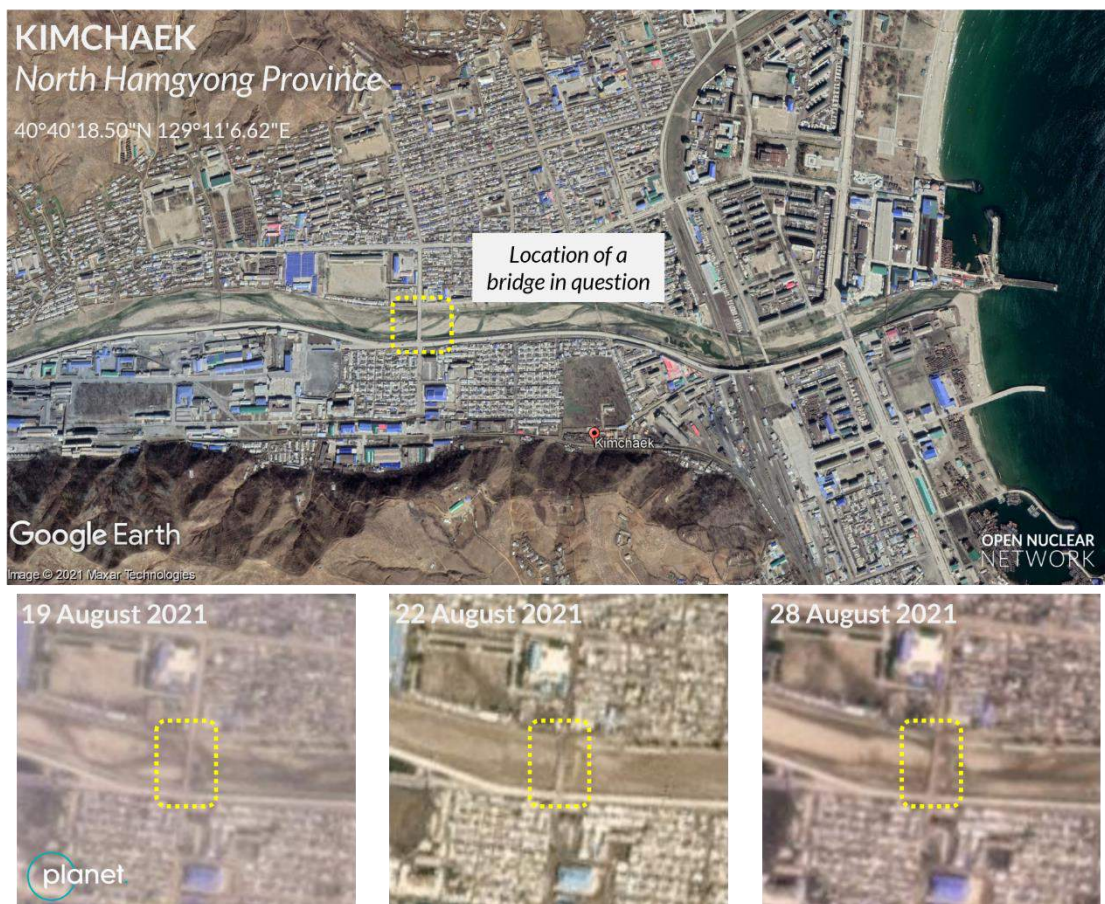
According to a KCTV report, the city of Kimchaek also experienced heavy rainfall in August. Satellite imagery from August 2021 shows that one of the key bridges in Kimchaek may have been damaged and repaired sometime between 19 and 28 August. Available satellite imagery from 22 August shows a possible sign of construction work at the bridge (Figure 23).

Figure 23. Overview of Kimchaek and the location of a bridge possibly damaged and then repaired in August 2021.
