# **ASSESSMENT OF THE IMPACT OF AUGUST 2021 RAINFALL AND FLOODING IN THE DPRK**

Katsuhisa FURUKAWA, Veronika BEDENKO, Jaewoo SHIN,  
XU Tianran

September 2021

In August 2021, the Democratic People's Republic of Korea (DPRK) experienced heavy rainfall and severe flooding. ONN has analysed available open-source information and identified locations of possible damage and assessed the scope of such damage. This paper provides a summary of ONN's findings.

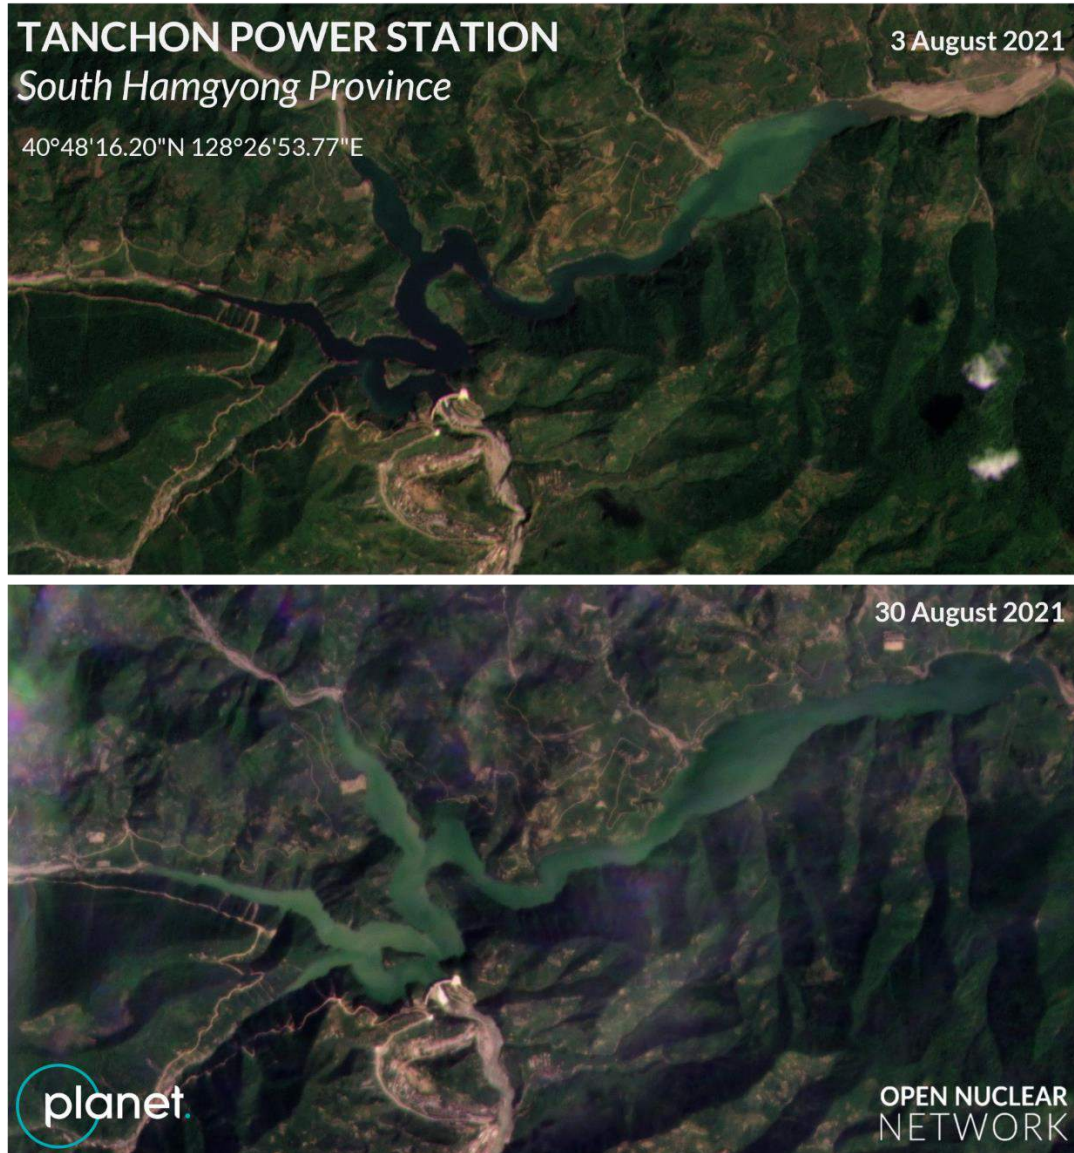
As noted above, water levels have risen significantly at dams and water reservoirs (Figure 24). The dams and reservoirs, which experienced a drought in July, were refilled

Figure 24. A comparison of the water levels at the Tanchon Power Station dam. Image © 2021 Planet Labs Inc. All Rights Reserved. Reprinted by permission.

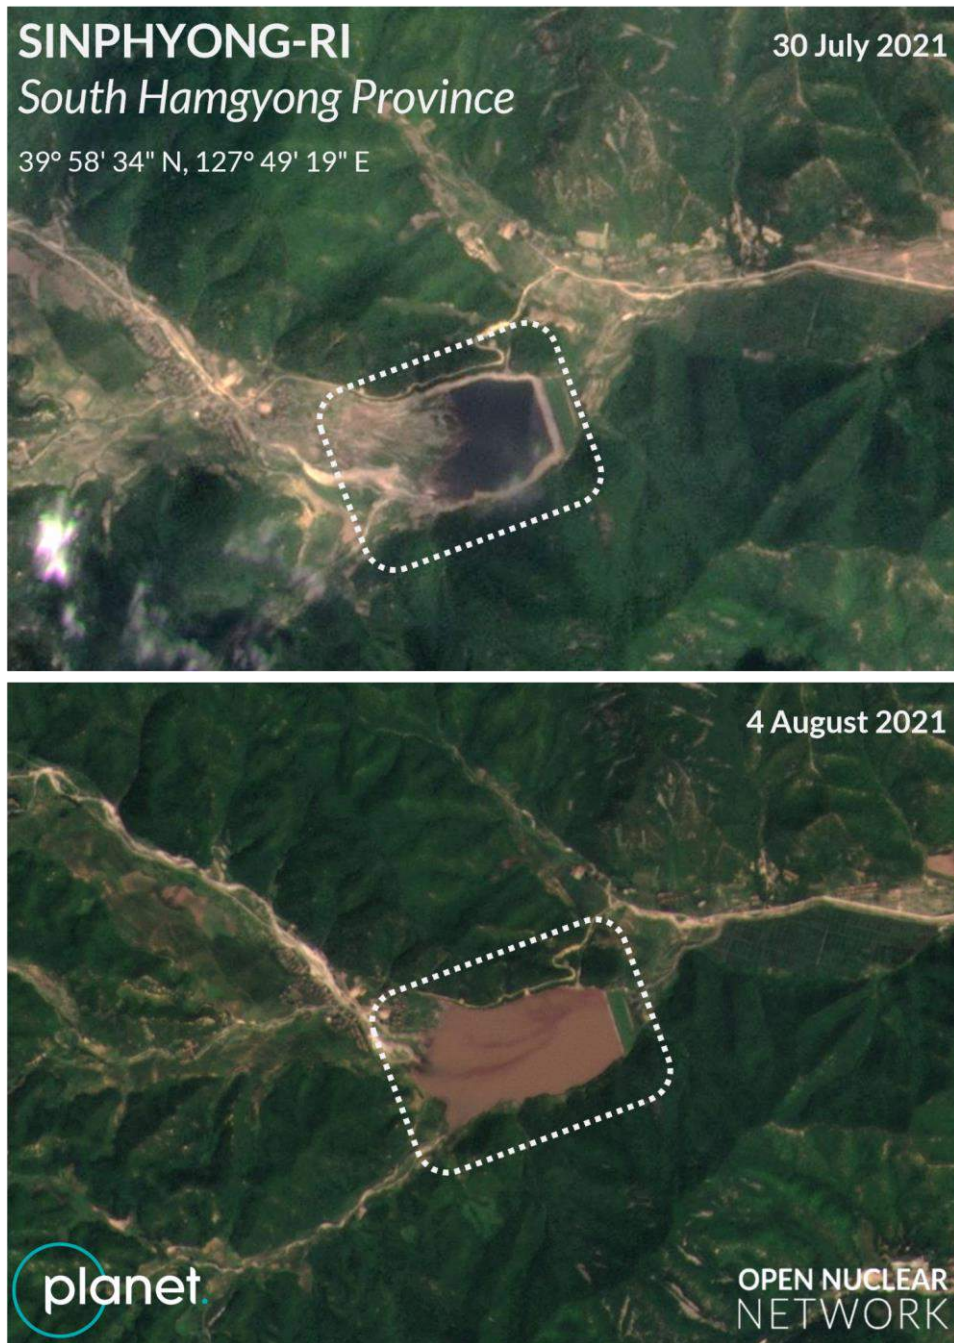
with water, and the water levels appear to have recovered (Figure 25). Although there are signs of possible overflow of water at some of the reservoirs, there are no visible signs of damage to these dams or reservoirs (Figure 26).

Figure 25. Significant increase in the water level at a reservoir near Sinphyong-ri, south of Hamhung. Image © 2021 Planet Labs Inc. All Rights Reserved. Reprinted by permission.

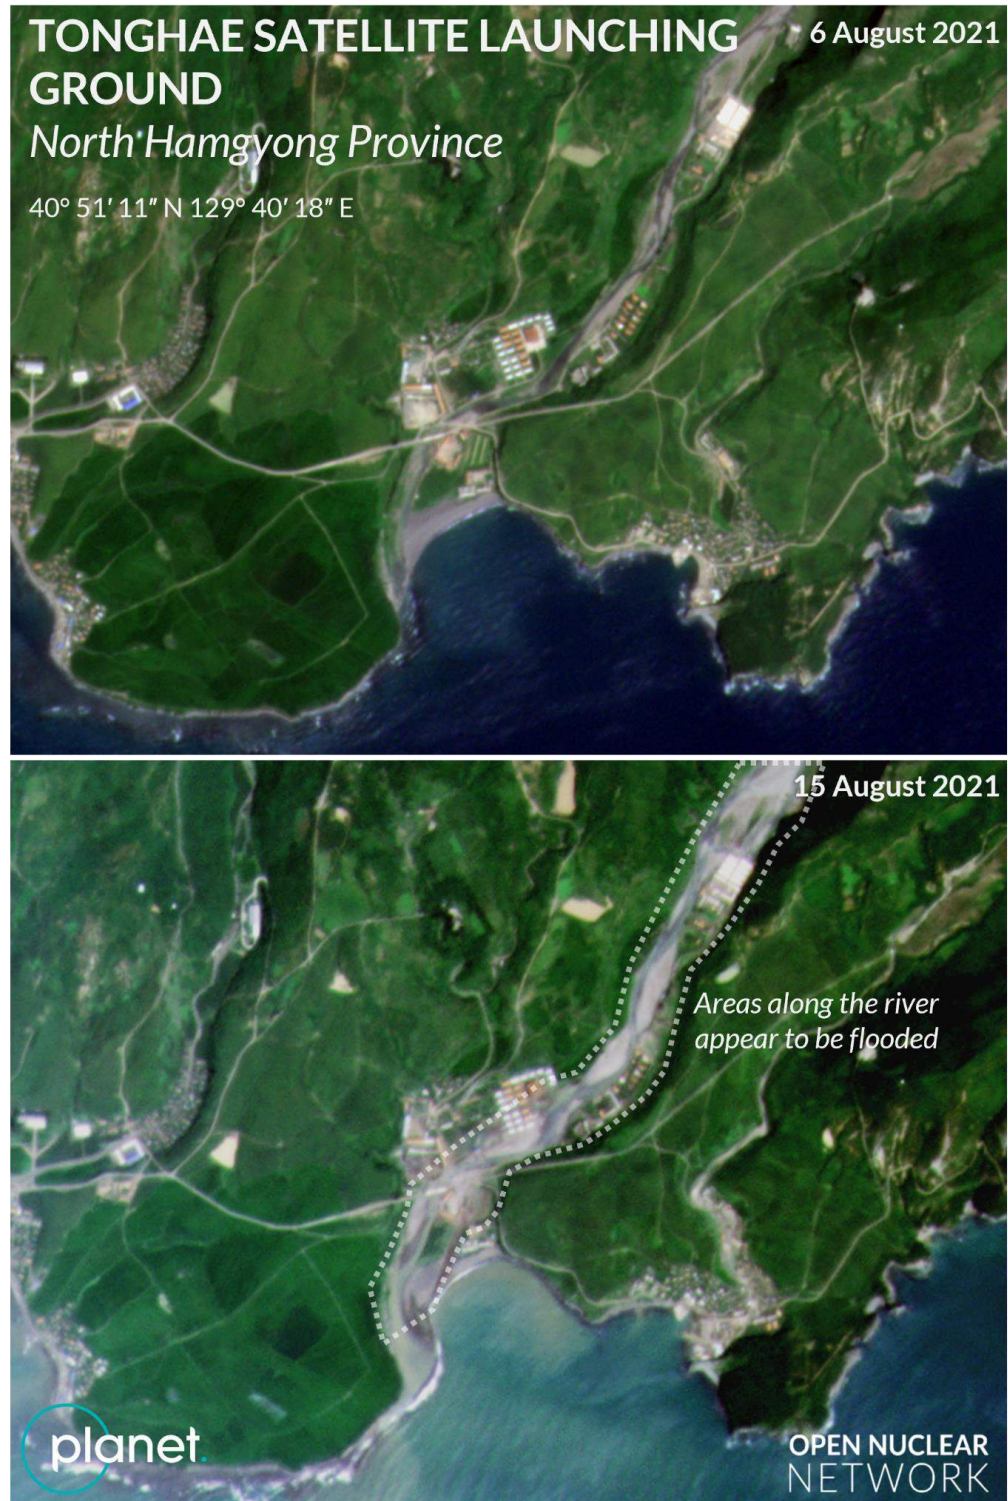
No damage was observed at most facilities known to be related to the DPRK's nuclear or ballistic missile programmes. The only exception is the Tonghae Satellite Launching

Ground, where some of the suspected launch control/administrative buildings and surrounding smaller buildings were flooded, but it is unclear whether these structures were damaged as a result of the flooding (Figure 27).<sup>17</sup>

Figure 27. Flooded area at the Tonghae Satellite Launching Ground.
